Testing and Monitoring of the READ Project House East Lansing, Michigan*

Prepared for:
United States Department of Energy
Office of Building Technology
State and Community Programs
1000 Independence Ave. SW
Washington, DC 20585
George James, Program Manager

Prepared by:
Armin F. Rudd
Florida Solar Energy Center
1679 Clearlake Road
Cocoa, FL 32922

11 February 1999

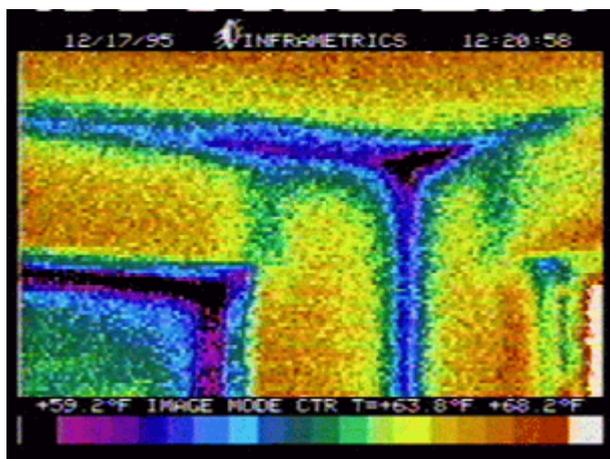
With 15°F outside temperature and 68°F inside temperature, the infrared scanning revealed no thermal insulation or air barrier defects that

would have a significant impact on energy use or comfort. However, a few defects were observed as follows:

1. headers over second story shed dormer window (front of house), likely uninsulated solid lumber header, see Figure 4;
2. both sides of shed dormer, triangular section, see Figure 4;
3. other, mostly conductive, thermal shorting at corners, wall to 1st floor ceiling connection, and some panel splines, see Figure 5.

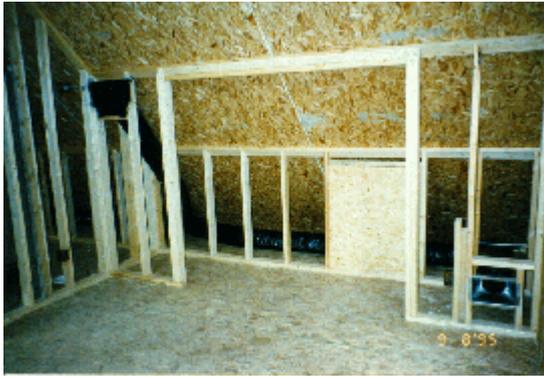
Building air leakage was measured using a calibrated fan (Ductblaster) to depressurize the house. The fan was installed in a blower door frame in the exterior door at the rear of the house. Three multi-point fan depressurization tests were performed on the house. For the first test the supply registers and return grilles were open, for the second test, they were taped off, and for the third test, the outside air inlet for the ventilation system was also taped off. Table 2 lists the results. The results show that this house had very little air leakage relative to much of conventional construction. In fact, it was one most airtight houses

tested by the FSEC EEIH program to date.

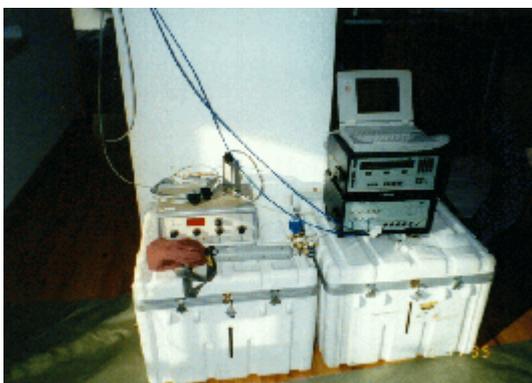
While the fan pressurization method of determining building air leakage allows the estimation of building air change rate with prescribed environmental conditions, the actual building air change rate at any given time can be measured by tracer gas methods. The actual building air change rate was measured using: sulfur hexafluoride (SF₆) as the tracer gas, a multi-zone photo acoustic gas analyzer, and a mass flow controller for constant injection of the tracer gas. Building air change rate varies over time due to influences of wind, thermal buoyancy, mechanically induced air flow, and door/window operation. Figure 8 is a plot of the hourly average air change rate as measured in four different locations in

the house, including: the basement, 1st floor, and 2nd floor. Figure 9 is a plot of the hourly average air change rate with all four samples averaged together. The time period spans 14 hours of measurement from 10 pm to 9 am. During this time, the house was occupied and the ventilation system was operating. The average air change rate over the 14 hour period was 0.17 h⁻¹.
